ALEXANDRIA AIRCRAFT LLC
Alexandria MN 56308

SERVICE LETTER B-110

May 8, 2007

SUBJECT: EXHAUST SYSTEM INSPECTION AND REROUTING MAGNETO "P" LEADS

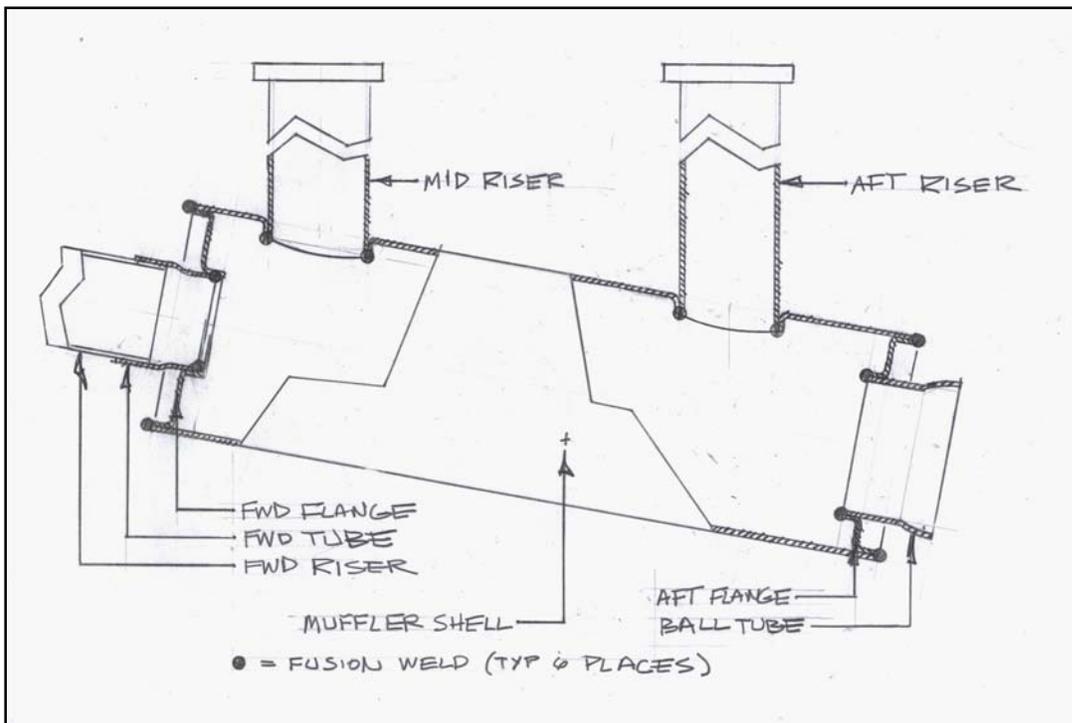
Figure 1: Typical Exhaust System
(Left side Looking Inboard)

There have been several serious accidents caused by exhaust system failures. Typically, the muffler fails at the weld which holds the ball joint to the muffler. The hot exhaust gasses then escape and melt the insulation on wires which are routed thru connector(s) on the left side of the firewall (Models 17-30A, 17-31A and 17-31ATC). These wires include the left and right Magneto "P" Leads (except for those aircraft which have Service Kit 1067: Rerouting Right Magneto "P" Lead installed). When both the left and right magneto "P" leads short to ground, the engine stops.

A typical exhaust system is illustrated in Figure 1. The figure has two cut-outs (one forward, one aft) each showing cross-sections thru the muffler assembly centerline. The figure is not drawn to scale and does not include the shroud for the cabin heat exchanger nor the external flange which supports same. The fusion welds to be inspected are shown as small black spots where the weld would be located on the cross-section; the actual welds go all around the tube. Thus, there are six welds which are considered critical and must be inspected. Two external welds join the Muffler Shell to the Forward and Aft Flanges. Four internal welds join: 1) the Forward Tube to the Forward Riser, 2) the Muffler Shell to the Middle and Aft Risers, and 3) the Aft Flange to the Ball Tube. Note - the Forward Riser slip-fits into the Forward Tube.

1. Remove the heat exchanger shroud.
2. Visually examine the two external welds which connect the Muffler Shell to the Forward and Aft Flange's. Look at the weld itself and where the weld ends. Visually examine the Forward and Aft Flanges for cracks, taking special notice at the flange radius.

3. Visually examine the slip-fit joint between the Forward Riser and the Forward Tube for wear and/or cracks in same parts; remove the Forward Riser if necessary.

4. Disconnect and remove the tail pipe assembly.
5. Use a light and inspection mirror to look into the muffler thru the inside of the Ball Tube and examine the internal welds which attach the Forward Flange to the Forward Tube and Aft Flange to the Ball Tube for cracks. Look at the welds themselves and where they end. Visually examine the interior surfaces of the Forward and Aft Flanges for cracks, taking special notice at the flange radius.

6. Use a light and inspection mirror to look into the muffler thru the inside of the Ball Tube and examine the internal welds which attach the Middle and Aft Risers to the Muffler Shell for cracks. Look at the welds themselves and where they end. Visually examine the interior surfaces of the Riser Tubes for cracks. Visually examine the radius of the Muffler Shell adjacent to the weld for cracks.
